# RIPARIAN BUFFERS IN THE TOWN OF HECTOR - DRAFT

Schuyler County, New York

## RIPARIAN BUFFERS

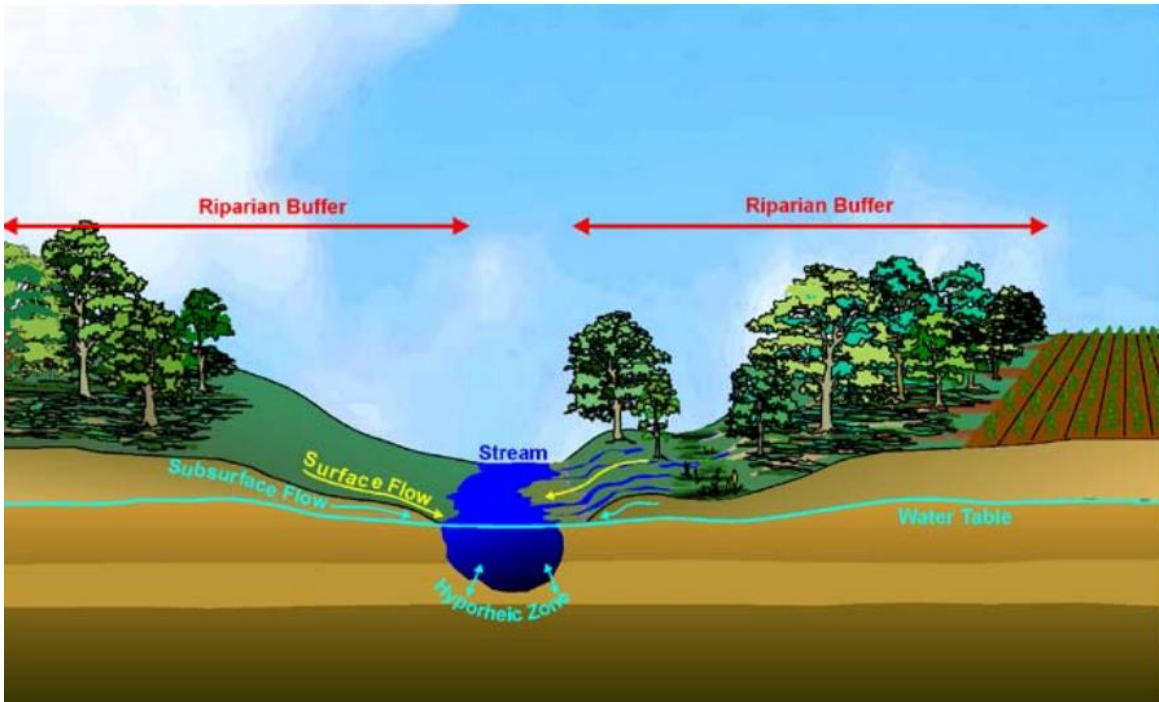
Figure 1. Riparian Buffers (From USEPA 2005)

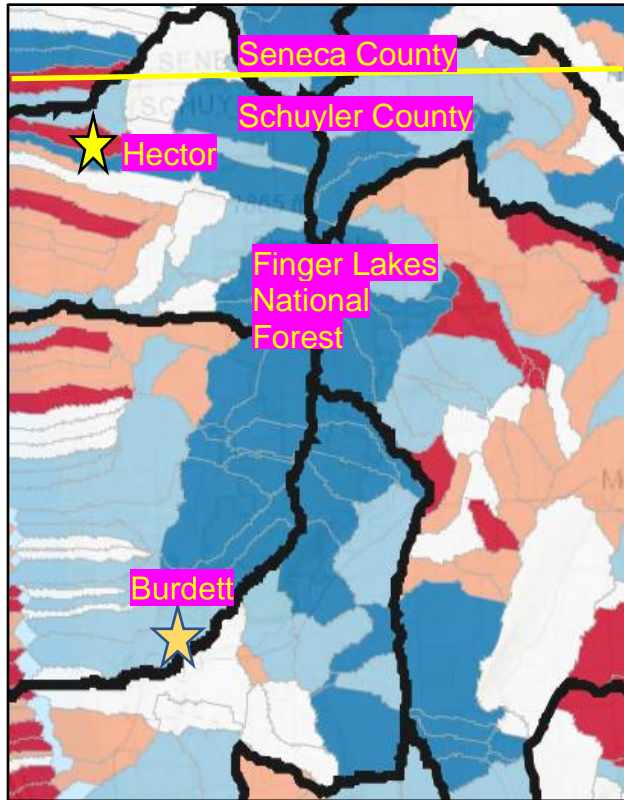
Figure 4. New York State Riparian Assessment – Catchments (NYSDEC 2017). See text for explanation of colors.

The results shown in Figure 3 are largely consistent with the assessment data from the New York State Riparian Opportunity Assessment (NYSDEC 2017). This NYSDEC document identifies locations where enhancement of riparian buffers will produce tangible benefits to water and habitat quality. Figure 4 shows an image taken from this statewide riparian assessment within the approximate boundary of the Town of Hector. Streams were given comprehensive scores that reflected a measure of ecological stress and ecological health. In general, dark blue and light blue areas have good riparian quality, white and tan areas have fair riparian quality and areas in red have poor riparian quality.

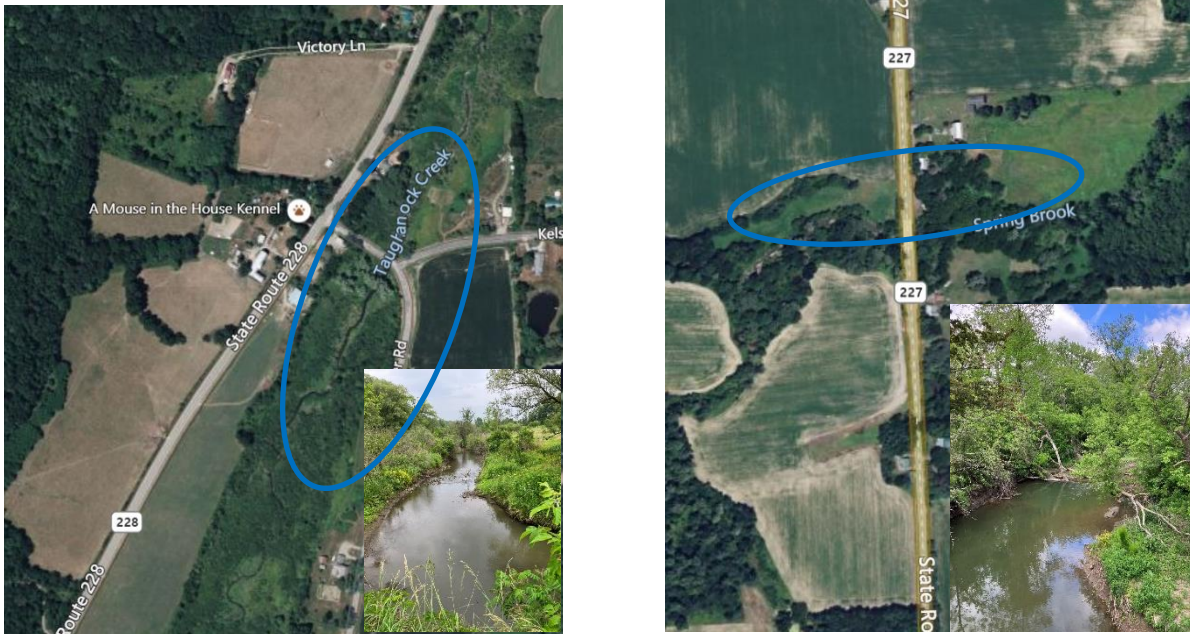
Riparian buffers rated as “Good” provide ecological and water quality benefits to the adjoining stream. Most of the Finger Lakes National Forest has riparian buffers rated good as part of this assessment (and with a high comprehensive score from the NYSDEC riparian assessment – see Figure 4). Good riparian buffers are characterized by mature trees extending at least 20 feet laterally from the edge of the stream on both sides of the stream. These streams are kept shaded and cooler by overhanging vegetation, providing benefits to fish, amphibians, reptiles, and aquatic insects. These high-quality buffers provide nesting and foraging habitat for birds and mammals, as well as wildlife corridors. Examples of good riparian buffers are Shown in Figures 5 and 6.

Figure 5. Examples of Riparian Buffers Rated as Good. Taughannock Creek at Schuler on Left. Spring Brook at Rt. 227 on Right. See Figure 3 for locations.

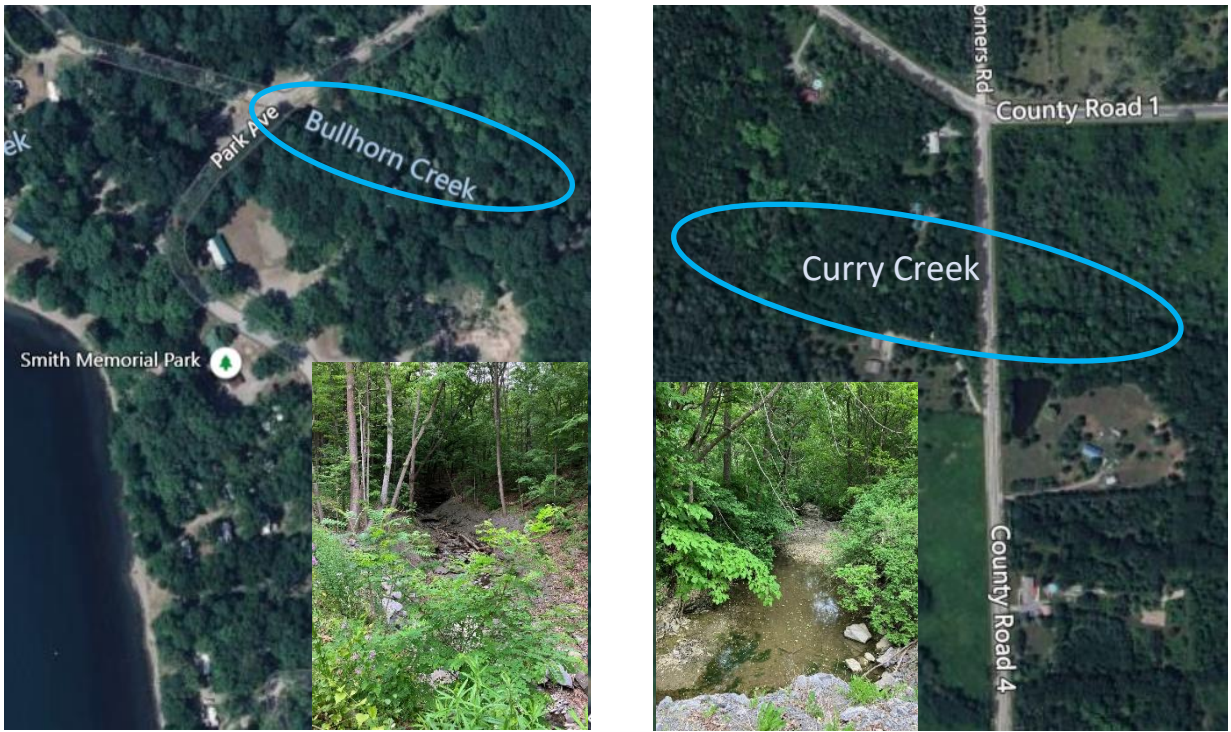
Figure 6. Examples of Riparian Buffers Rated as Good. Bullhorn Creek at Smith Park on Left. Curry Creek at County Road 4 on Right. See Figure 3 for locations.

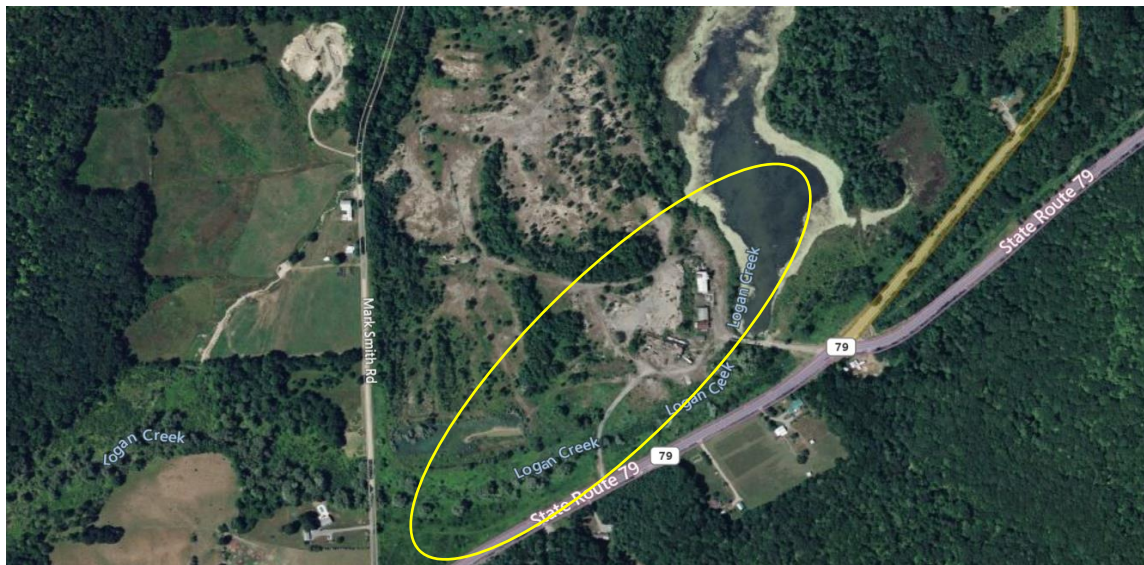
Riparian buffers were rated as “Fair” if they were generally less than 20 feet wide or if there were small riparian stretches with no riparian buffer. Examples of fair buffers are shown in Figures 7 - 9.

Figure 7. Riparian Buffer Rated as Fair. Logan Creek Near Gravel Pit at Rt 227. See Figure 3 for location.

The next steps to improving riparian buffer vegetation and stream integrity in the Town of Hector would be to evaluate buffer areas identified as poor or fair on property owned by landowners that are interested in steamside planting. There are programs that can help in supplying trees and shrubs at low or no cost and the Town of Hector could assemble a group of volunteers to plant the trees and shrubs. The NYSDEC has a “Buffer in a Bag” program as part of its “Trees for Tribs” Program (<https://www.dec.ny.gov/animals/77710.html>). They supply bags of 25 tree and shrub seedlings to public and private landowners by an application process. Both the Natural Resource Conservation Service and U.S. Fish and Wildlife Service have programs to restore fish and wildlife habitat or install environmentally beneficial conservation practices.

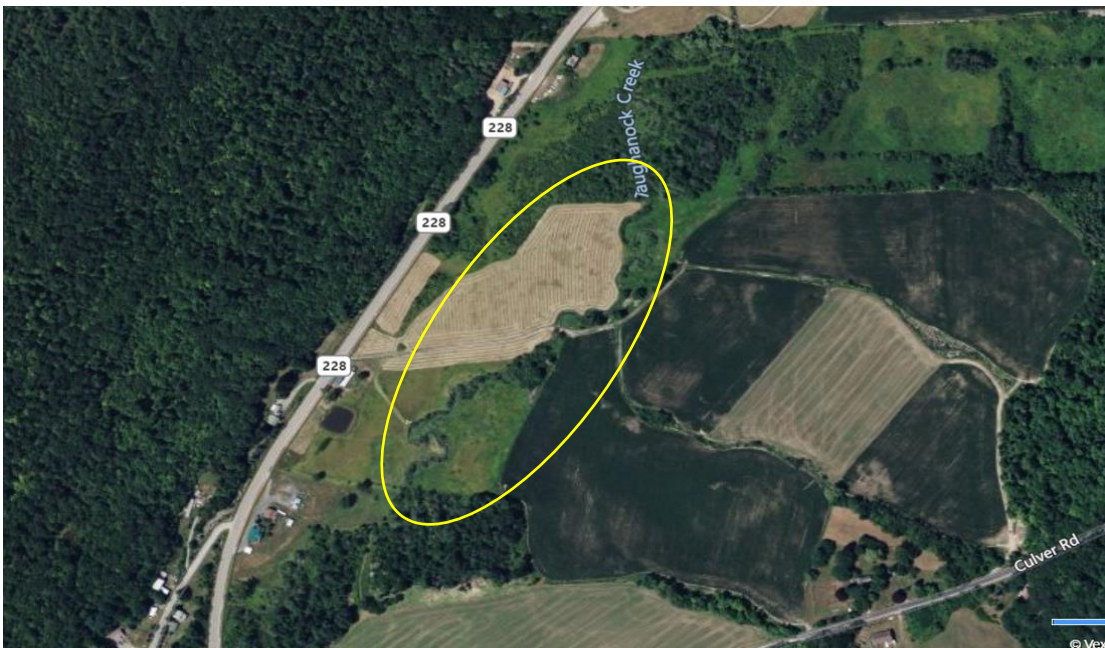
Figure 8. Riparian Buffer Rated as Fair. Taughanock Creek Near Smith Valley. See Figure 3 for location.

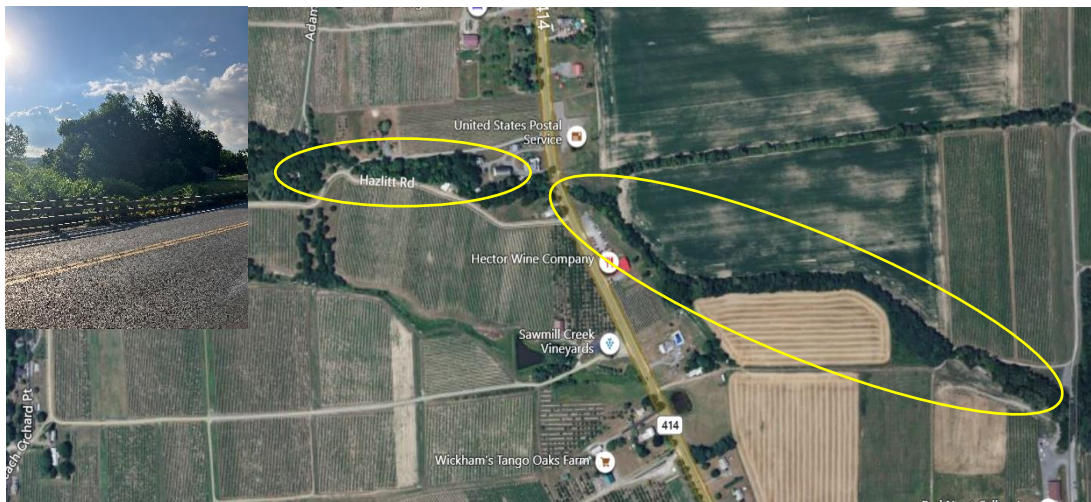
Figure 9. Riparian Buffer Rated as Fair. Hazlitt Road Tributary to Seneca Lake. See Figure 3 for location.

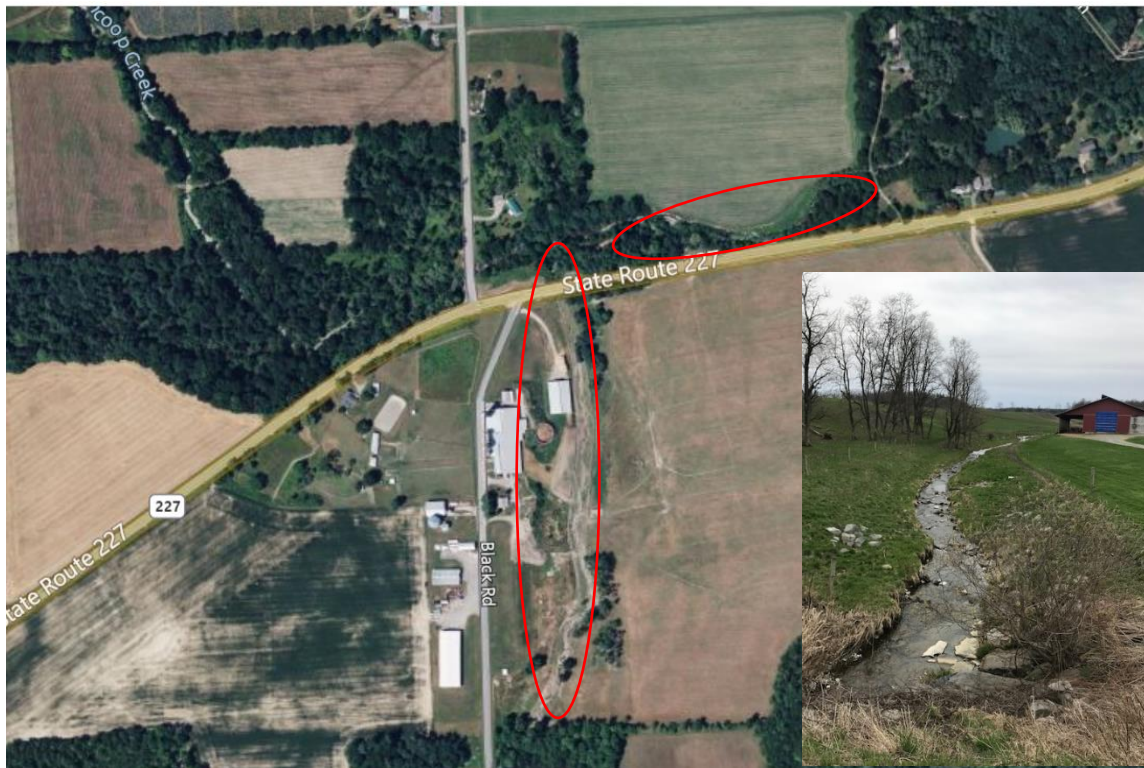
Riparian buffers rated as “Poor” have no forested or shrub vegetation next to the stream other than scattered trees. Poor riparian buffers are rare in the Town of Hector and are typically along headwater or ephemeral streams. They are also generally in areas where agricultural activities directly border the stream. Examples of poor riparian buffers are shown in Figures 10-12.

Figure 10. Tributary to Hencoop Creek at Black Road. See Figure 3 for location.

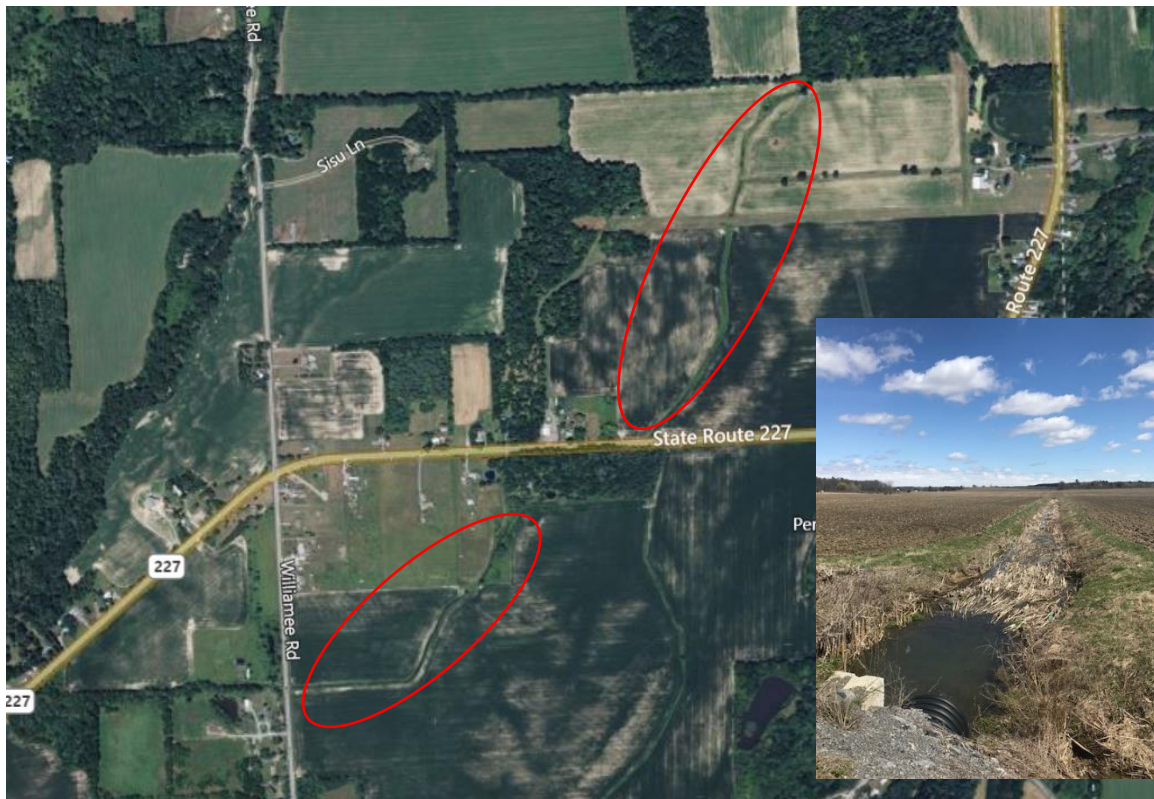
Figure 11. Tributary to Spring Brook Crossing at Willamee Road. See Figure 3 for location.

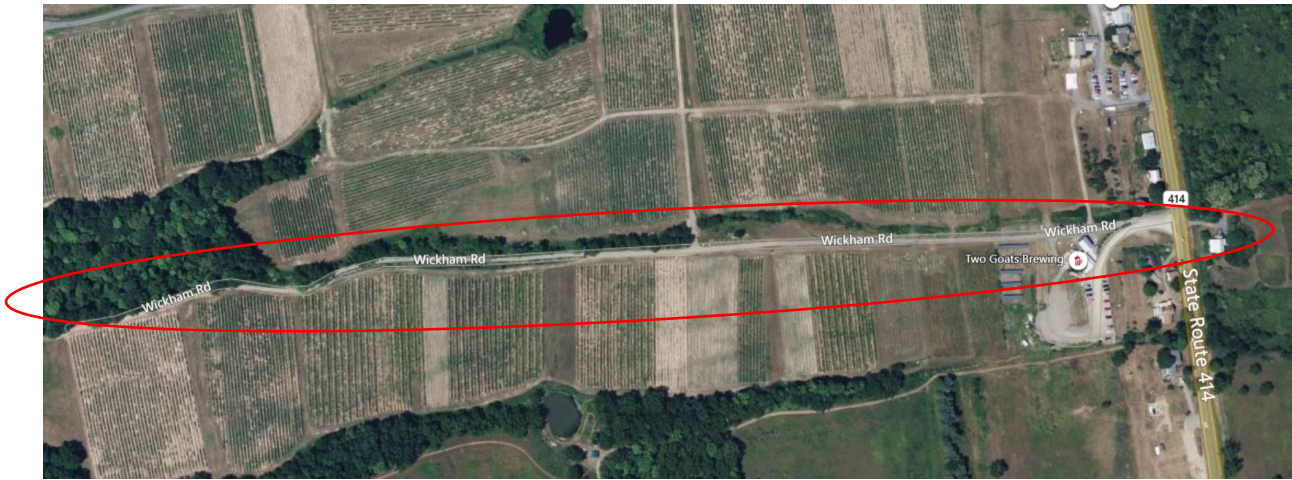
Figure 12. Tributary North of Two Goats Brewing. See Figure 3 for location.
